SITE VISIT REPORT

Date: March 17, 2011

Project: The Woodlands

Location: Marchwood Place and Matheson Crescent

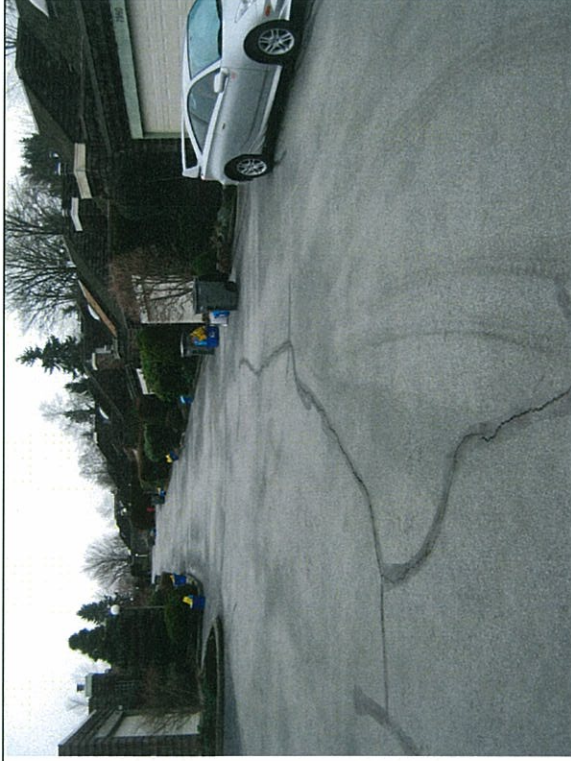
Photo 1: Photo dated March 4, 2009 looking north on Marchwood Place, showing pre-existing asphalt cracks.

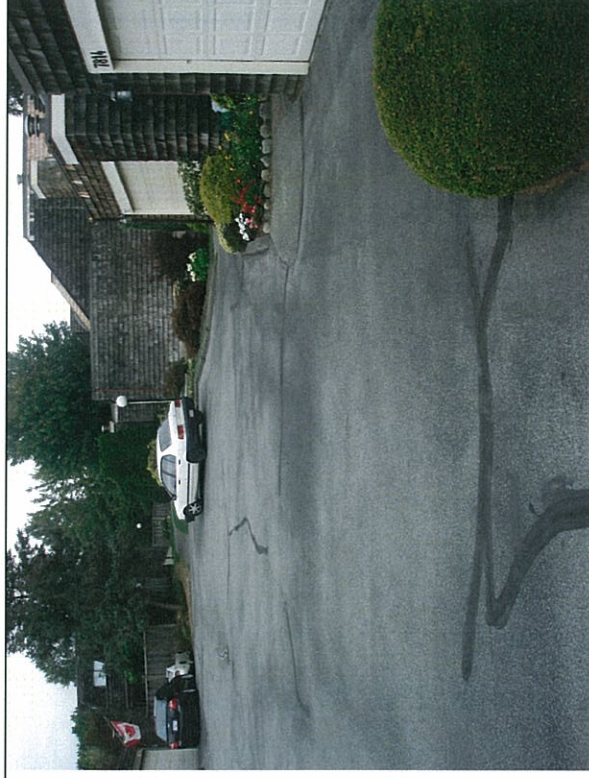
Photo 2: Photo dated March 4, 2009 of the north end of Marchwood cul-de-sac, showing pre-existing asphalt cracks present.

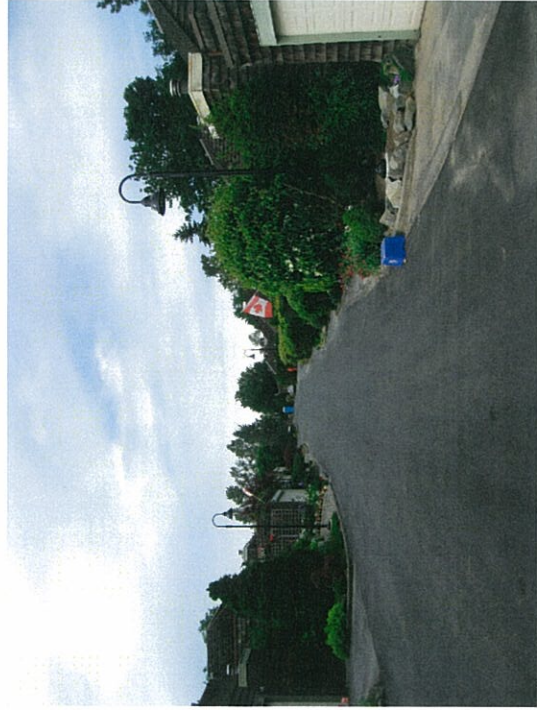
Photo 3: Marchwood Place looking north, June 24, 2010, after new pavement placed.

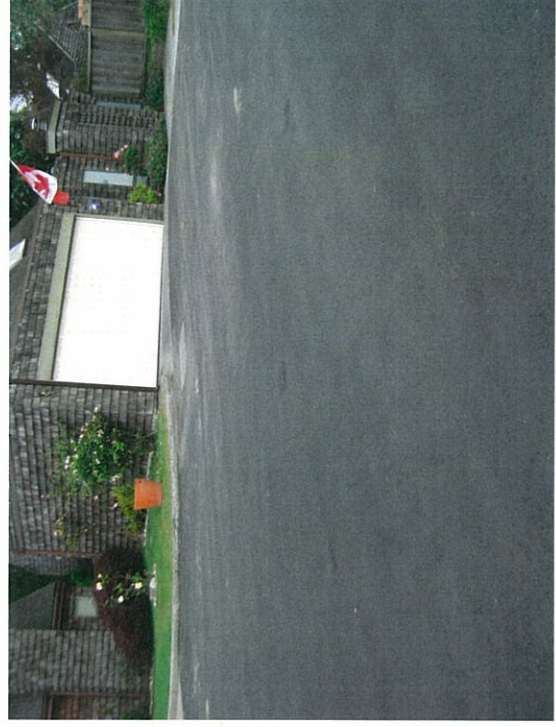
Photo 4: Marchwood at the north end cul-de-sac, June 13, 2010, with the new pavement.

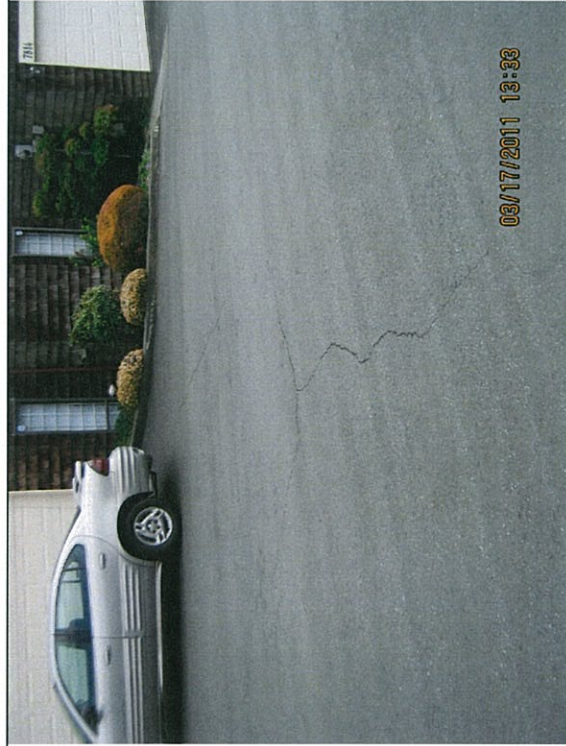
- 2.9 A mill and pave is not a solution to improving poor base gravels or old asphalt, but will cover most shallow cracks in the existing pavement.
- 2.10 As noted in this inspection, the cracks showing in the new overlay are from pre-existing cracks in the original pavement.

Photo 5: Photo taken March 17, 2011 showing crack reflecting through the overlay from the original crack as seen in Photo 2.

- 3.1 Crack seal the cracks before the asphalt sealer is placed on Marchwood to stop any water from entering the asphalt structure and frost heaving the overlay causing pot holes.

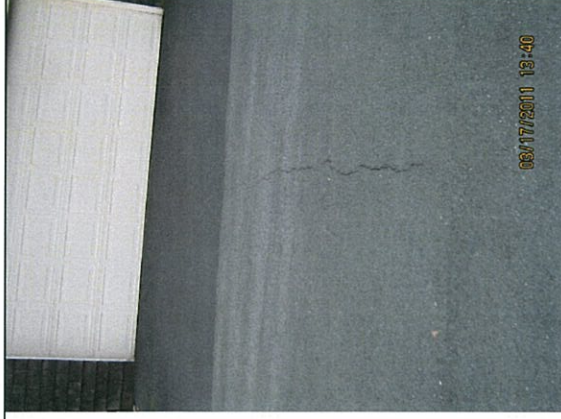
Photo 6: Photo taken March 17, 2011 showing crack that starts in the driveway reflecting through the overlay, as it did pre-construction.
